# **Wellington Battery Energy Storage System (BESS)**

## **Fire Safety Study**

**October 2025**

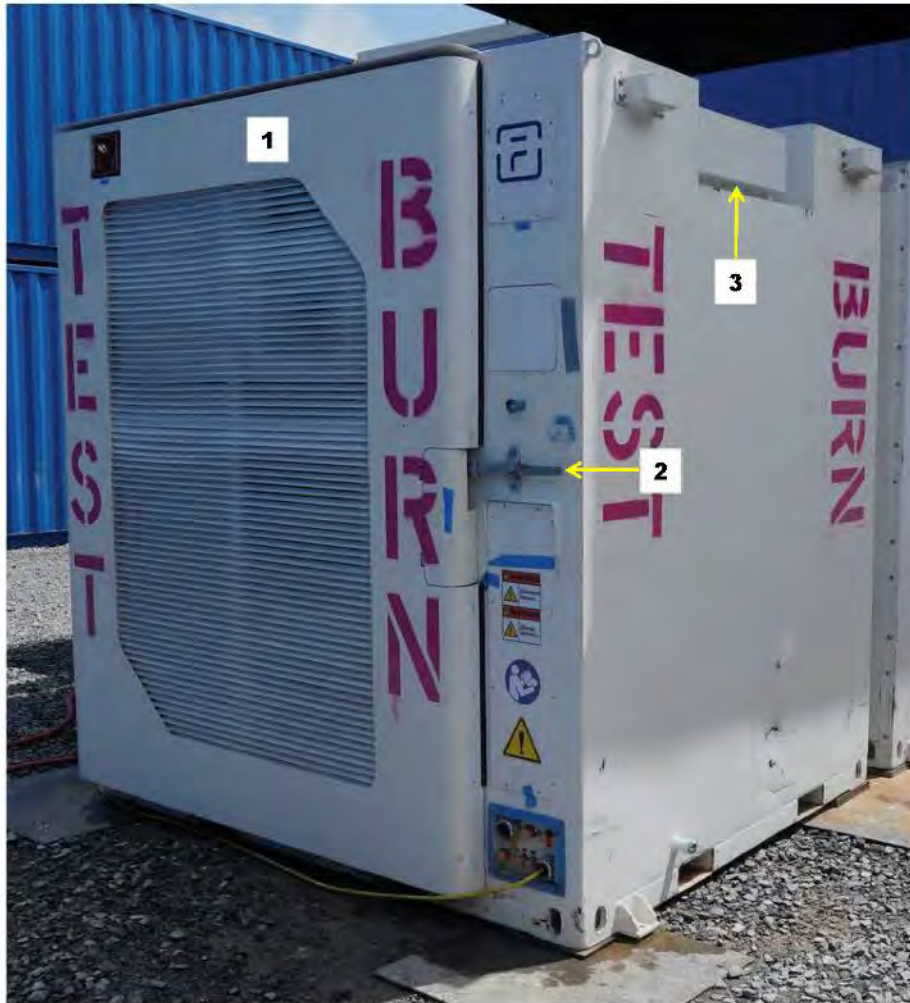
Each of the 16 modules within a cube contains 52 cells. The cube's cell, module, and unit level specification are shown below in Table 1.

**Figure 1. A photograph of a Fluence Cube.**

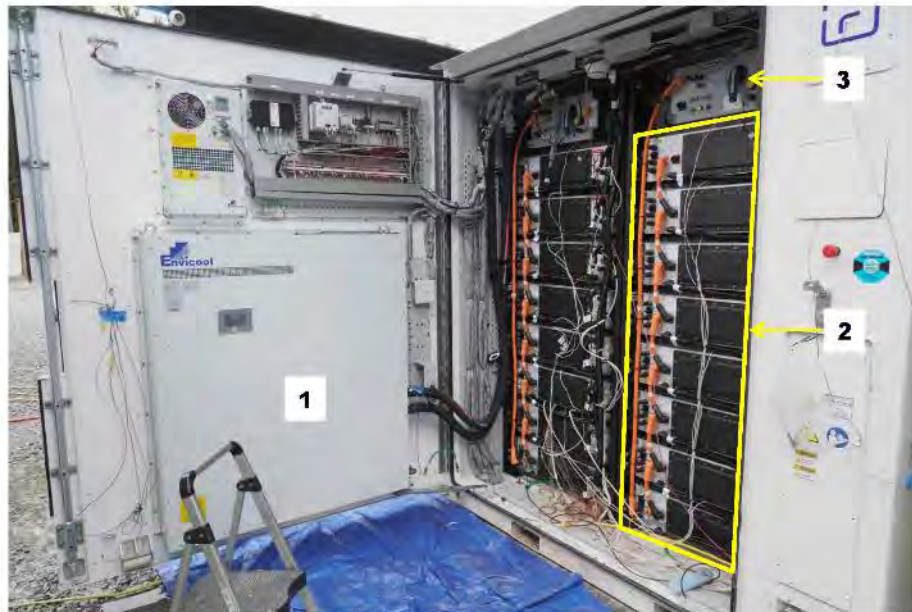
**Figure 2. A photograph inside the BDBT initiating unit.**

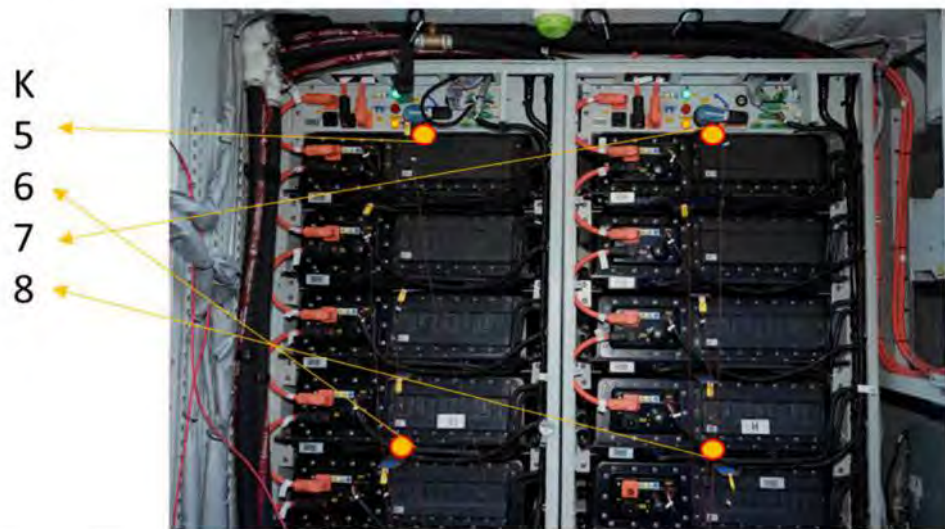
**Figure 11: Thermocouple locations within target 1.**

Note: All thermocouples indicated here were placed towards the back of the module as close to the initiating unit as possible

Figure 11 through Figure 13 shows the target units and the thermocouple locations associated with each unit. On the target units, thermocouples were placed in areas expected to receive the greatest temperature rise due to fire inside the initiating unit.

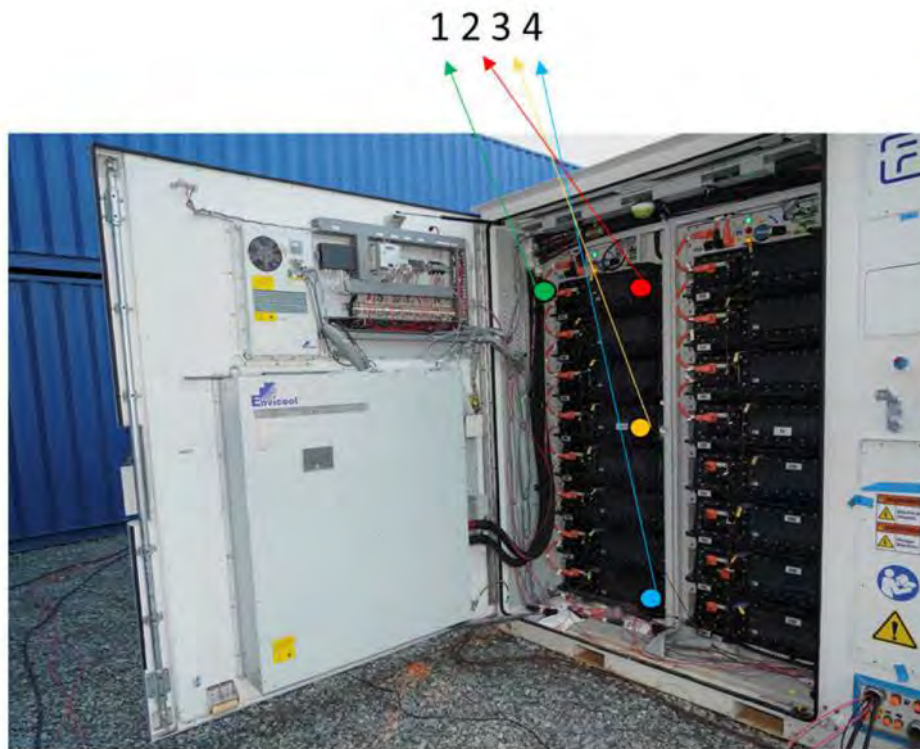
Figure 13: Thermocouple locations inside target 3.

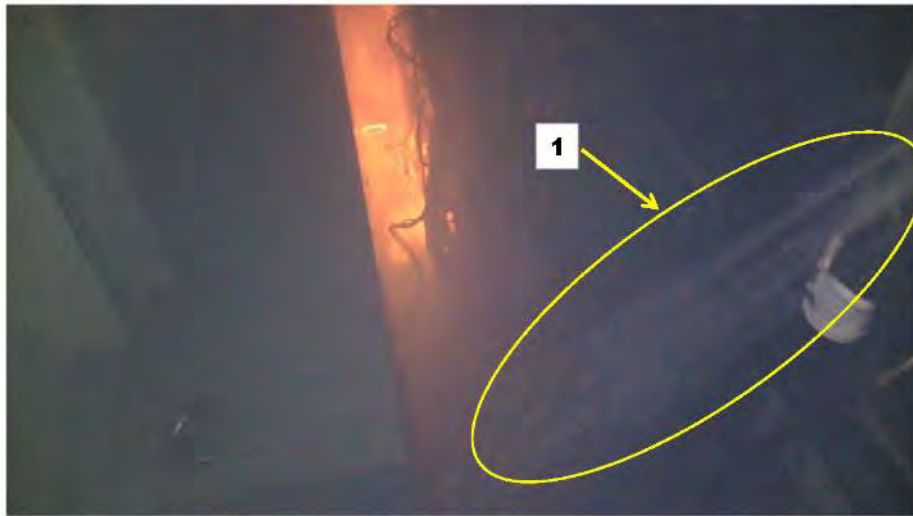
Figure 19. A screen capture shows coolant lines leaking inside the initiating unit while flames are also visible (1:53).

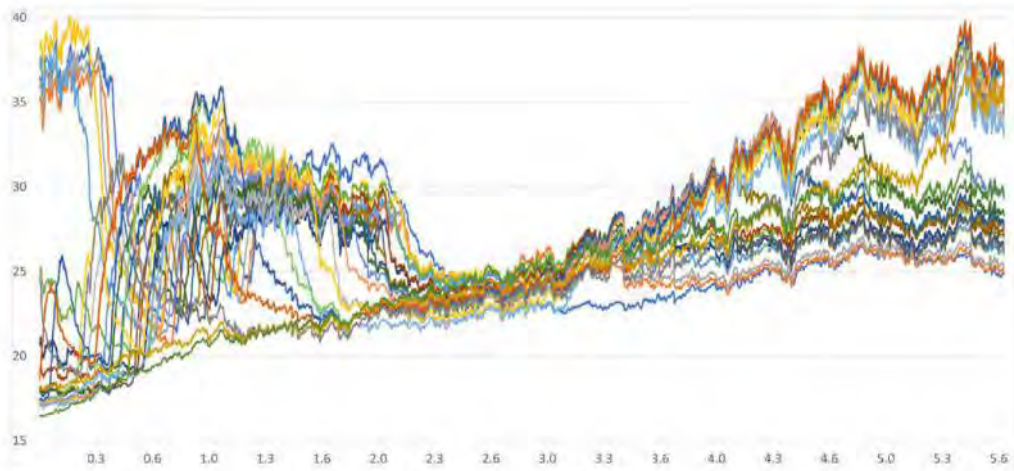
Figure 37: Temperatures of all target wall thermocouples (°C) vs. time (h).

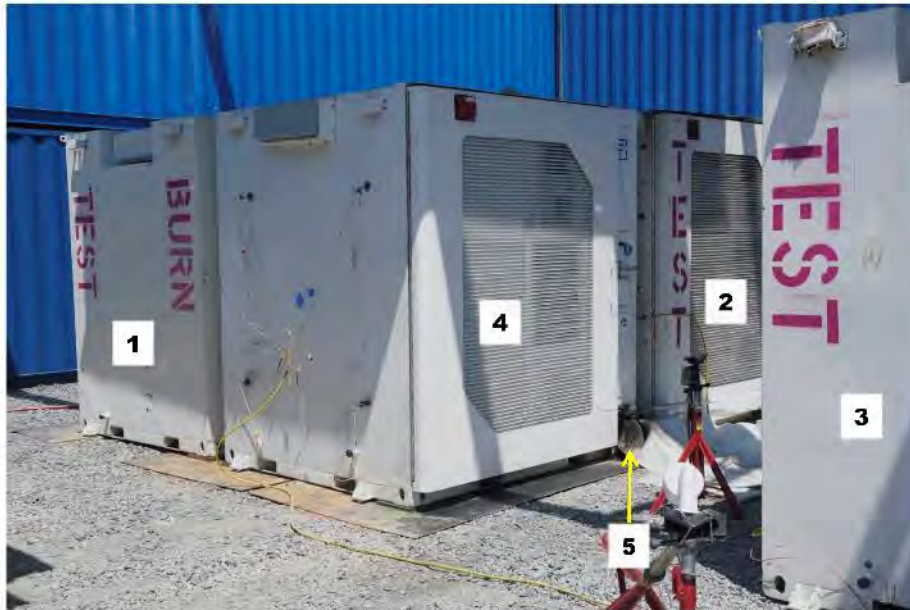
**Figure 52. A photograph of the initiating and target cubes after the test.**

1. Target 1 cube
2. Target 2 cube
3. Target 3 cube
4. Initiating unit
5. Soot staining on fire blanket

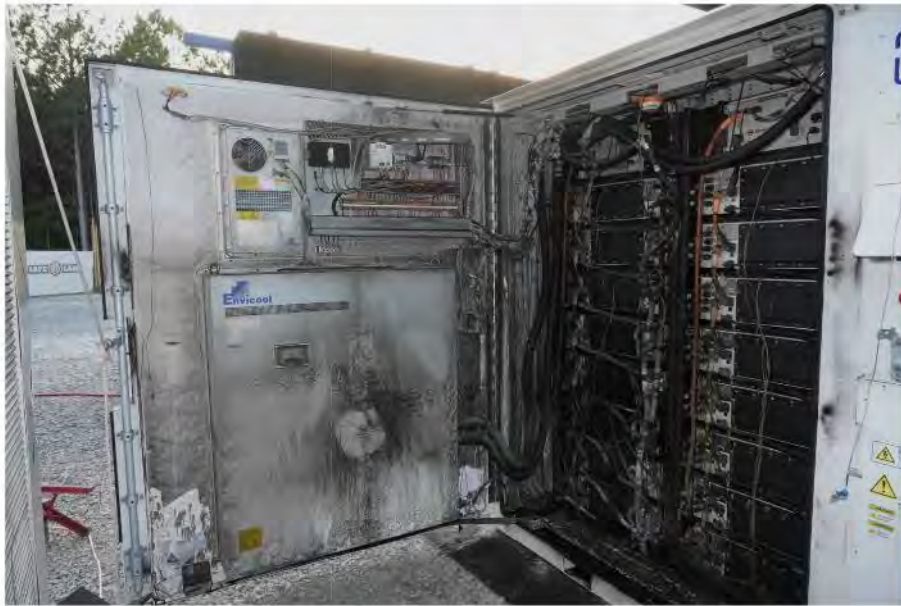
**Figure 54. Initiating unit after the BDBT.**

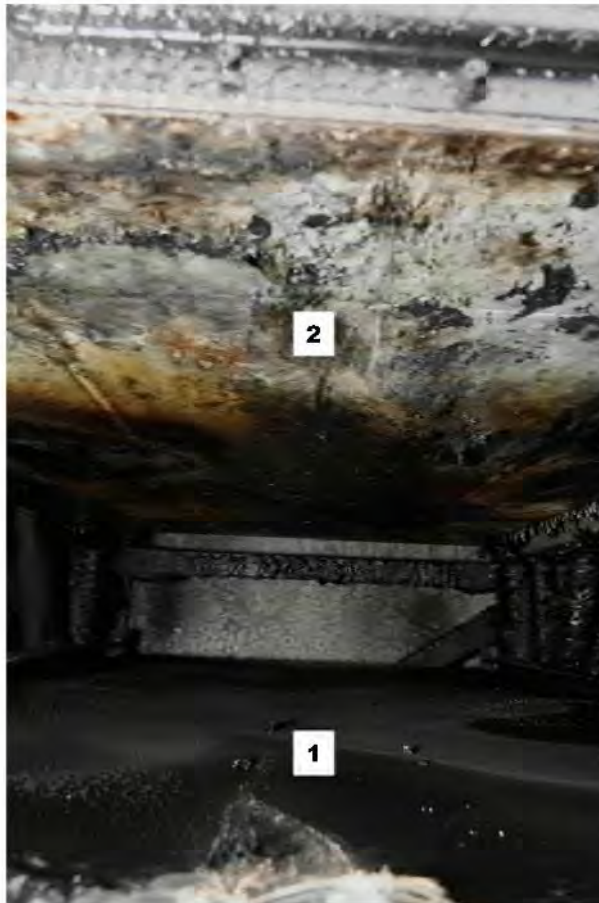
**Figure 58.** A photograph inside the rack after the initiating module was removed.

1. Top of Module 1-7
2. Heat damage to the bottom of Module 1-5

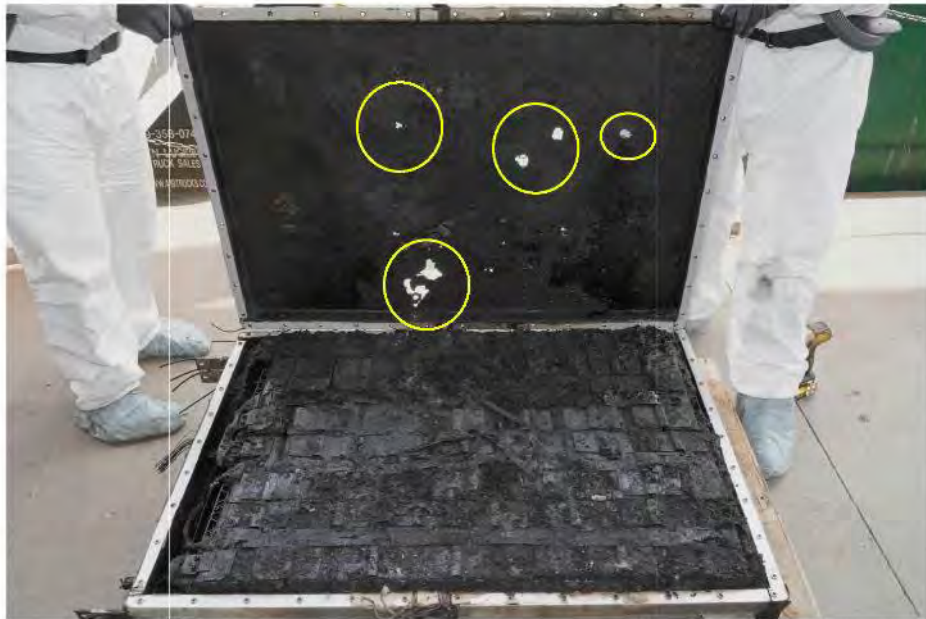
**Figure 59. A photograph inside the initiating module as the lid is being removed.**

1. Holes in lid (yellow circles)

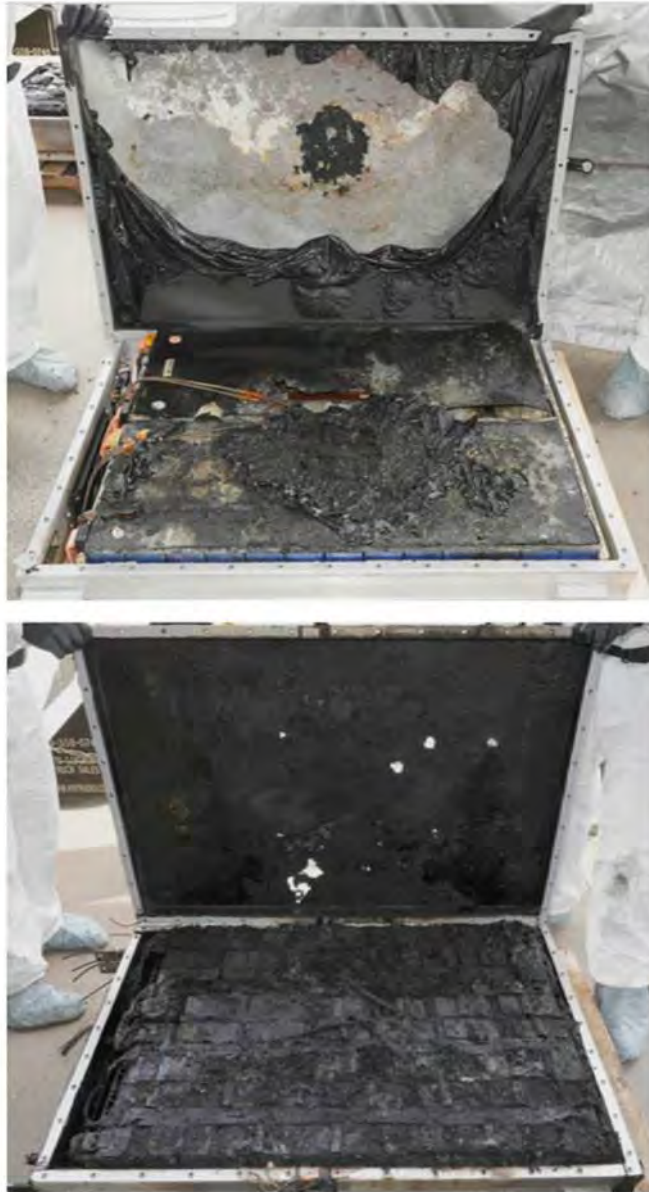
Figure 60. A comparison between the UL 9540A initiating module (top) and the BDBT initiating module (bottom).
